Fermi 2
6400 North Dixie Hwy., Newport, Michigan 48166
Tel: 313.586.5201 Fax: 313.586.4172

Subject: Licensee Event Report (LER) No. 97-014

TITLE (4) **Turbine Building and Auxiliary Building Mezzanine Not Fully Meeting License Condition 2.C.9**

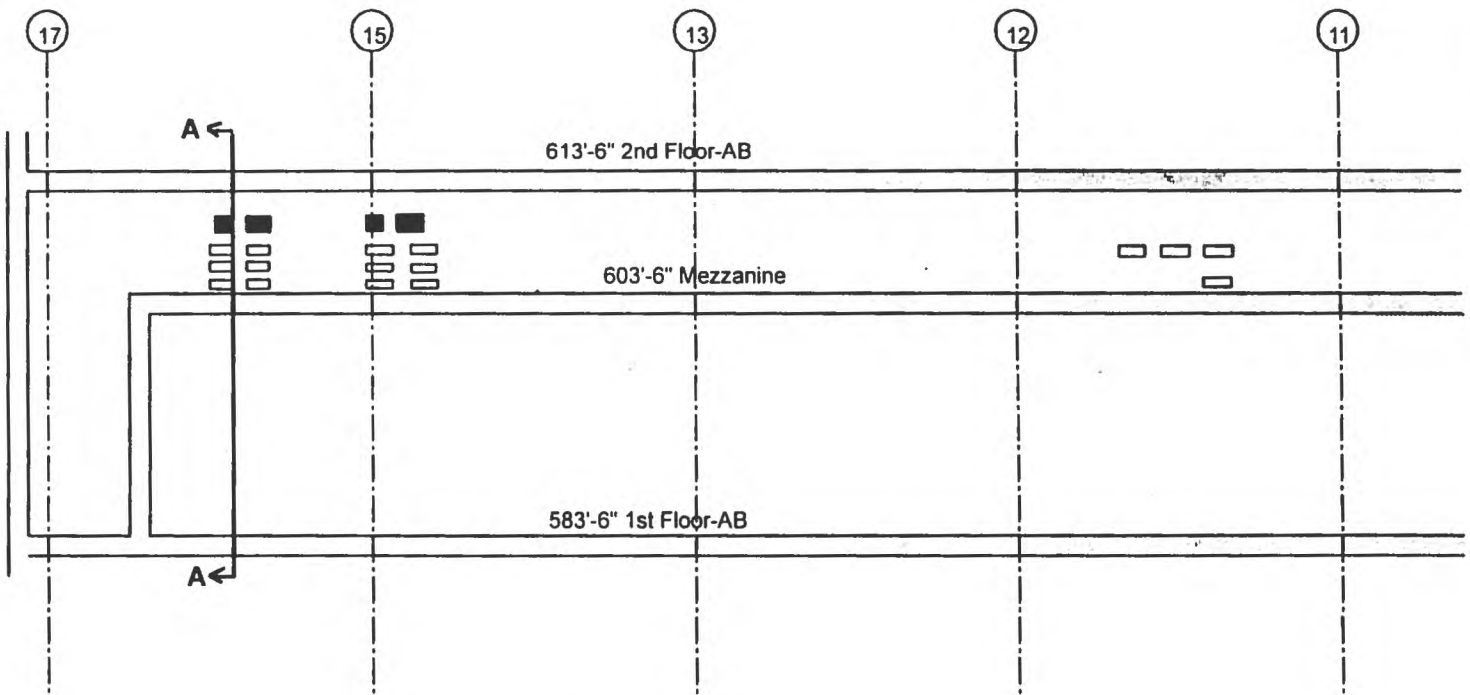
During a scheduled mid-cycle outage and while performing an independent design verification review for Engineering Design Package (EDP) 28140 "Install Evaporative Coolers for Drywell Cooling", it was discovered that four of the twenty penetrations [PEN] in the west turbine building wall were not sealed as required for a fire rated barrier. Electrical cable and cable tray penetrations in this area of the turbine building wall also penetrate the adjacent auxiliary building wall which is separated by a 4 inch seismic air space. The auxiliary building wall is the fire rated separation barrier and the adjacent turbine building wall is a fire rated barrier. Identification of the unsealed penetrations prompted a review of the fire hazards analysis and the 10CFR50, Appendix R assumptions used for this area. This review was completed on October 10, 1997 and revealed that of the 20 penetrations per wall, 16 were not sealed in the auxiliary building wall and 4 were not sealed in the turbine building wall. There were no openings which were unsealed at both the turbine building wall and the auxiliary building wall. The 16 unsealed penetrations in the auxiliary building wall (Refer to attached sketches) are located over a horizontal distance in excess of 25 feet and interface with areas which contain cable trays [TY] of both redundant shutdown divisions. The lack of penetration seals in the fire barriers would allow a fire in the turbine building to enter into an auxiliary building area containing cable trays of both Division I and Division II safe shutdown divisions.

During the installation of the penetration seals in the auxiliary building and turbine building walls, the significance of the 4 inch seismic air space was not recognized. Since the penetrations are in close proximity to each other a fire could propagate through an unsealed penetration in one building via the 4 inch seismic air space and into another unsealed penetration in the adjacent building. The turbine building wall and parallel auxiliary building wall were treated as a single wall. When sealing the openings which penetrated both walls, the more accessible side of the "wall" was chosen to be sealed. Field Engineering Memorandum (FEM) P-3724 dated February 25, 1983 reviewed and approved the installation of 16 seals on the turbine building side and 4 seals on the auxiliary building side. Thus the total number of penetrations in this area was perceived as being sealed.

Sketch 1 AS FOUND CONDITION, AB WALL
 East Auxiliary Building Wall Along Column H
 Between 11 and 17.
 First Floor and 603'6" Mezzanine

Note: Black Penetrations are sealed, White Unsealed

Various options for an engineering design modification were studied to determine the best solution to bring this area into compliance. It was determined that design changes to seal the turbine building wall in conjunction with an evaluation of the auxiliary building wall using the guidance of Generic Letter (GL) 86-10, "Implementation of Fire Protection Requirements," will provide compliance with the Appendix R requirements. The four electrical penetration openings in the turbine building wall will be sealed by the end of the sixth refueling outage (RF06).

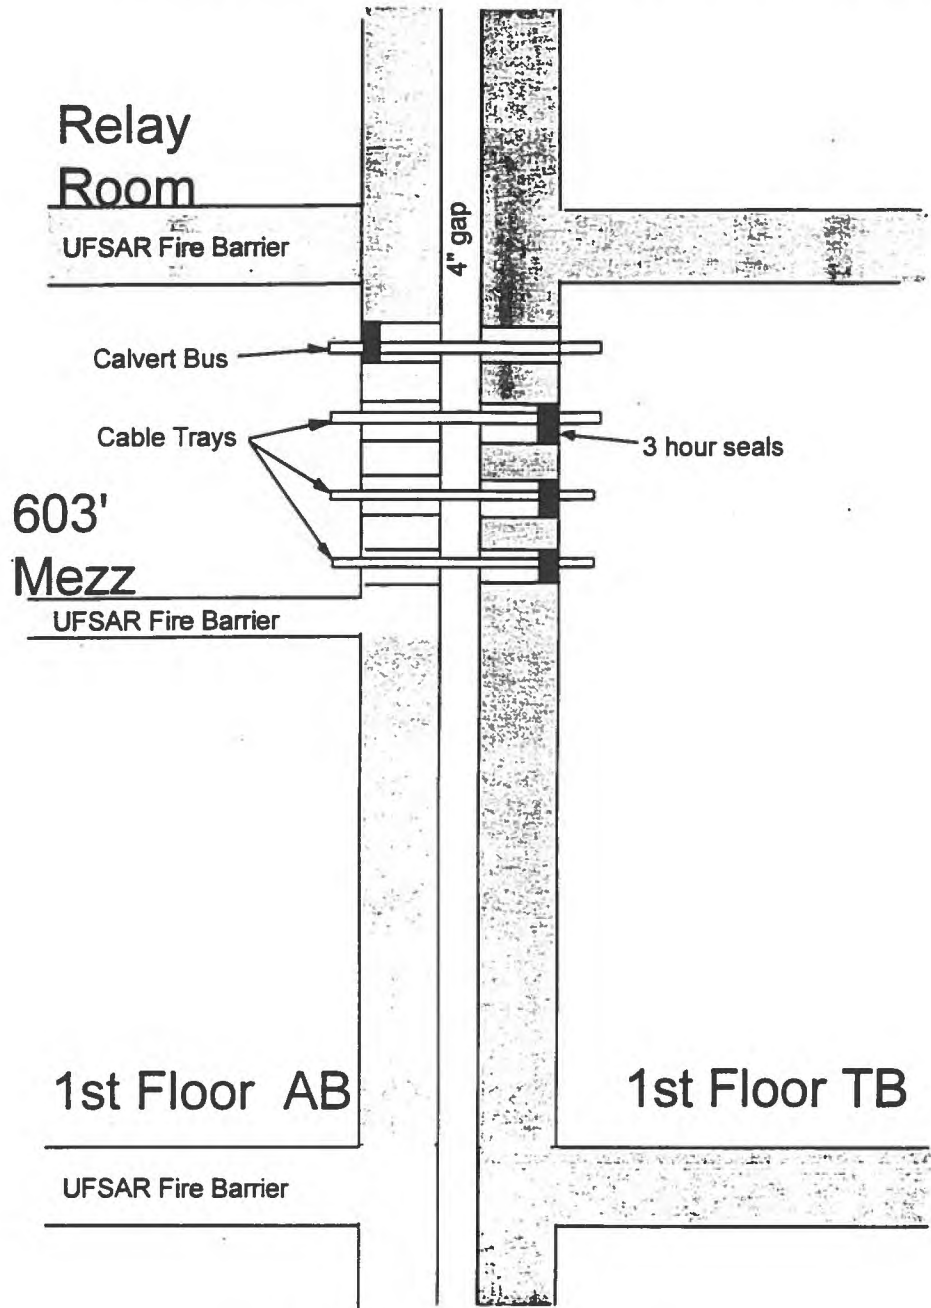
Auxiliary Building/Turbine Building Walls-Section A-A

Sketch 2, As Found Condition
